DEPARTMENT OF TRANSPORTATION

Contract #: 04-0120F4Cty: SF/ALA Rte: 80 PM: 13.2/13.9File #: 69.28**WELDING INSPECTION REPORT****Resident Engineer:** Pursell, Gary**Address:** 333 Burma Road**City:** Oakland, CA 94607**Report No:** WIR-000930**Date Inspected:** 15-Nov-2007**Project Name:** SAS Superstructure**OSM Arrival Time:** 1300**Prime Contractor:** American Bridge/Fluor Enterprises, a JV**OSM Departure Time:** 2330**Contractor:** Zhenhua Port Machinery Company, Ltd (ZPMC), Changxing Island **Location:** Shanghai, China**CWI Name:** Xu Lefang**CWI Present:** Yes No**Inspected CWI report:** Yes No N/A**Rod Oven in Use:** Yes No N/A**Electrode to specification:** Yes No N/A**Weld Procedures Followed:** Yes No N/A**Qualified Welders:** Yes No N/A**Verified Joint Fit-up:** Yes No N/A**Approved Drawings:** Yes No N/A**Approved WPS:** Yes No N/A**Delayed / Cancelled:** Yes No N/A**Bridge No:** 34-0006**Component:** 77, 89, 114 Meter Mock-Up & OBG**Summary of Items Observed:**

WELDING INSPECTION REPORT

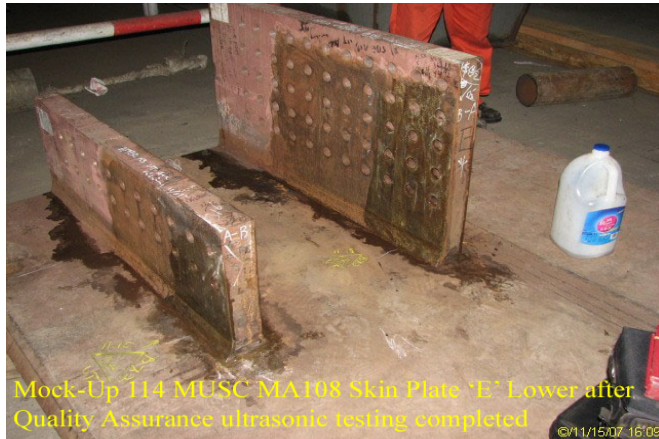
This Quality Assurance Inspector performed ultrasonic testing on complete joint penetration weld repairs to MUSC-MA108 Face E Lower, welds 1 & 2. For details see ultrasonic testing report TL-6027 dated November 15, 2007.
